NASA CR-66840

METEOROID PENETRATION DETECTOR DEVELOPMENT PROGRAM

FINAL SUMMARY REPORT  
VOLUME I

Prepared under Contract No. NAS1-7043 by  
MARTIN MARIETTA CORPORATION  
Denver, Colorado

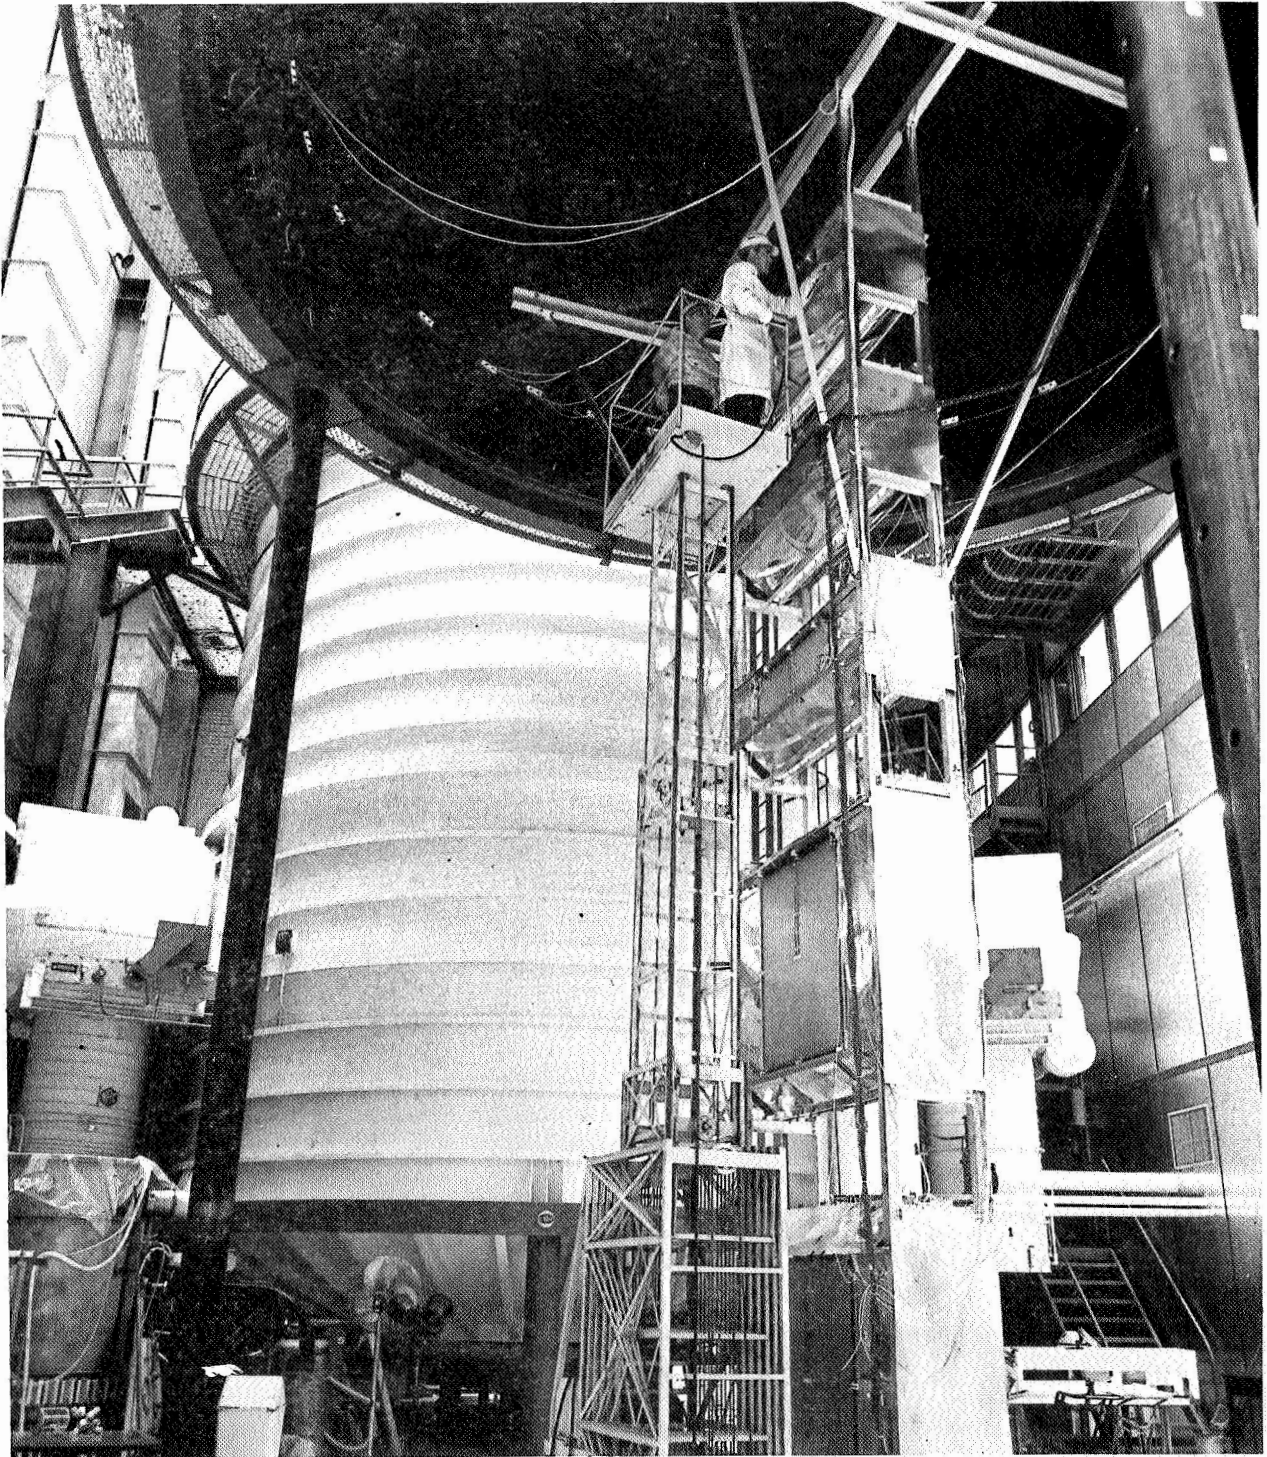
Figure 155.- Post-Thermal Vacuum Soak Test Examination of B1 A Panel,  
S/N 0000101

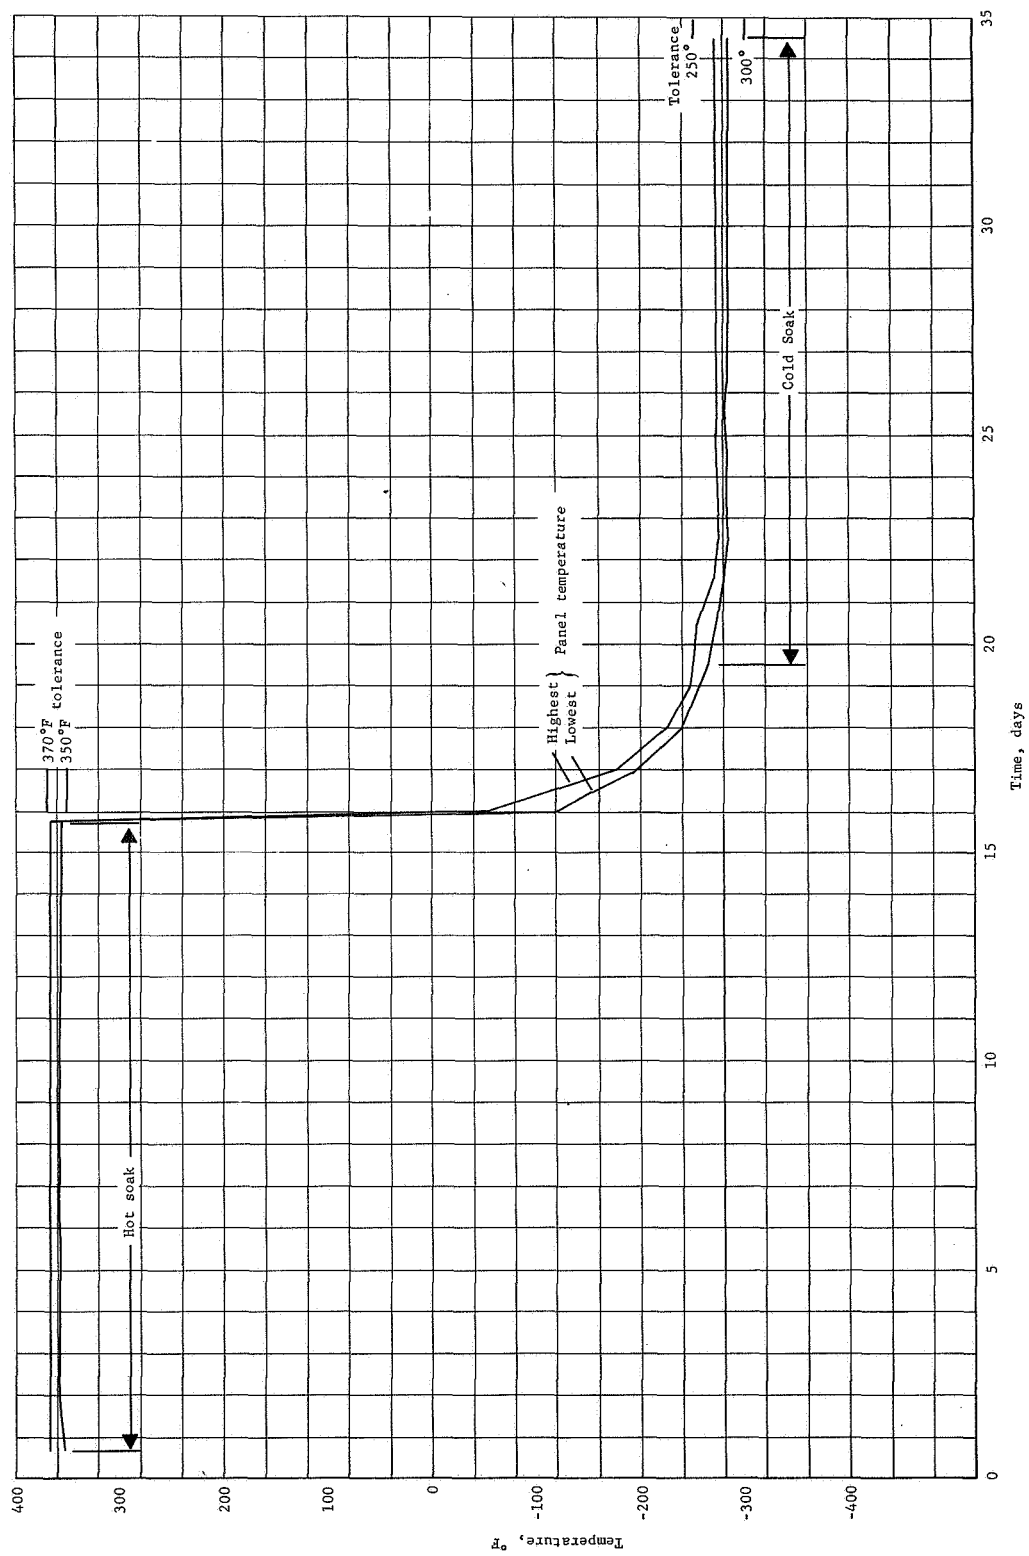
Figure 156.- Temperature History Summary

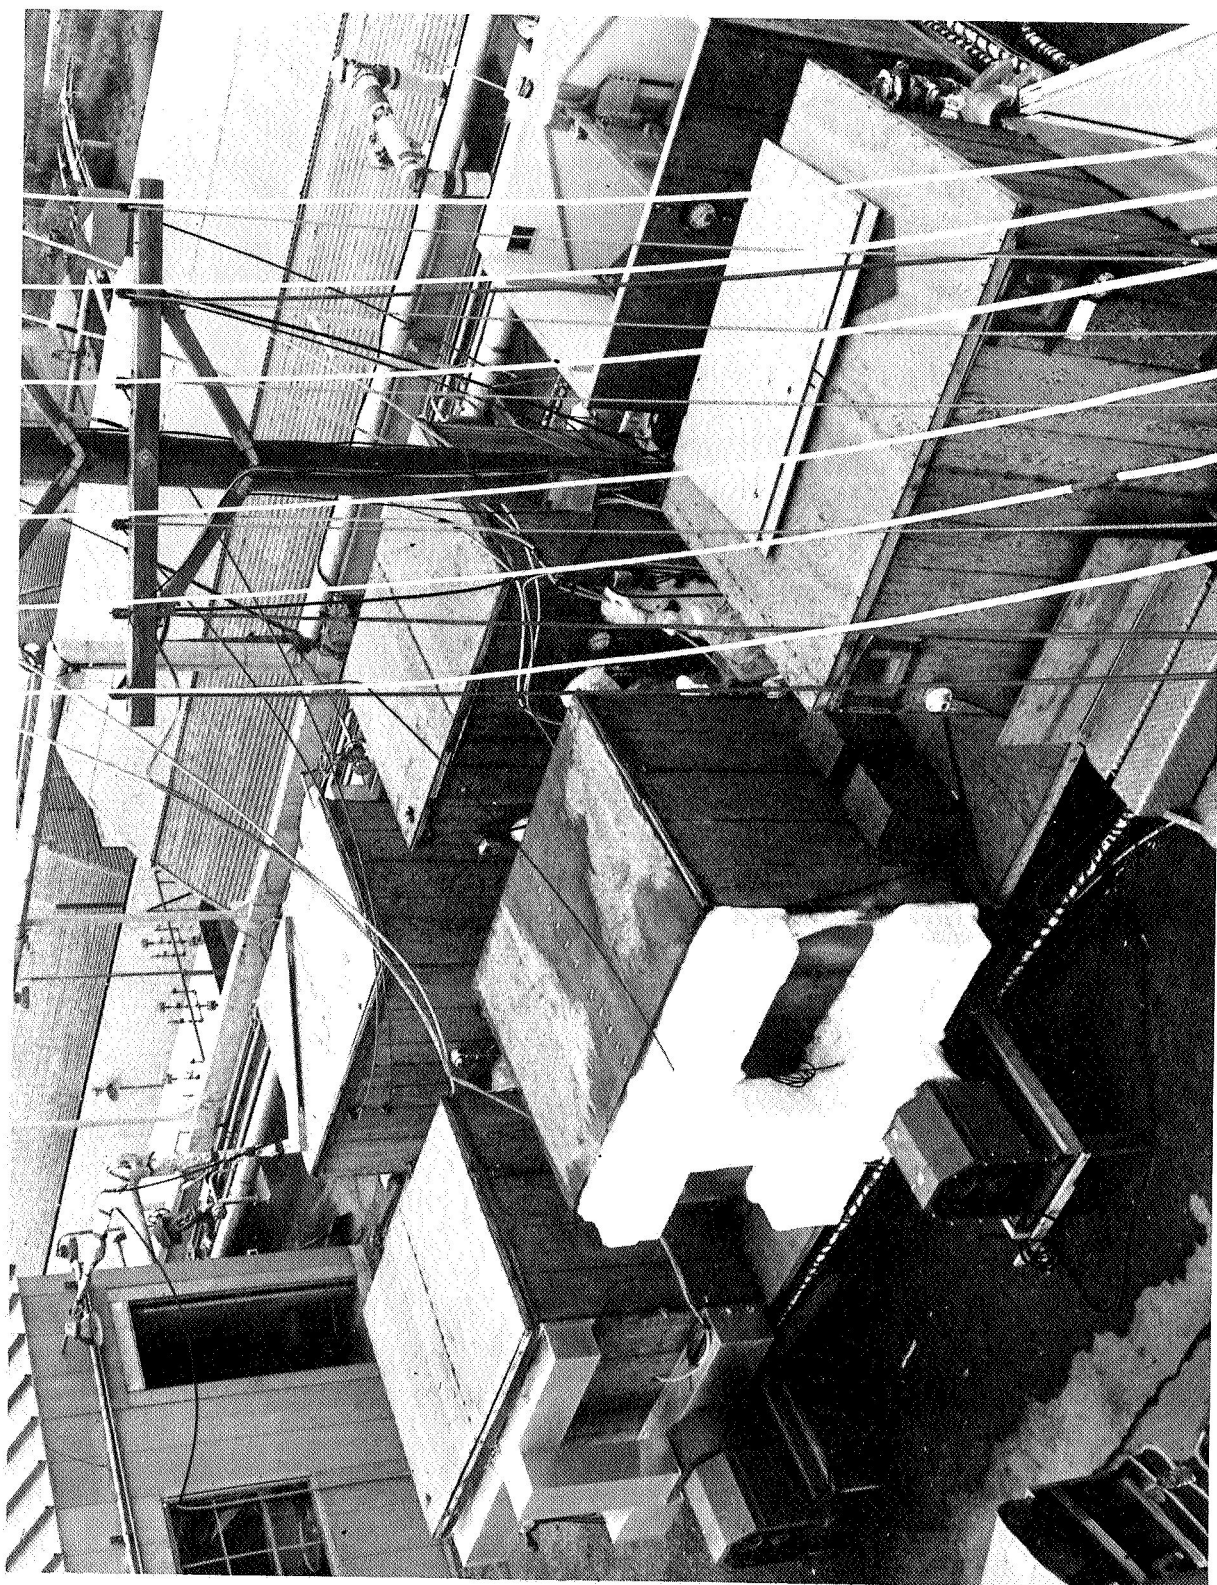
Figure 157.- Overall View, ALC Test Setup

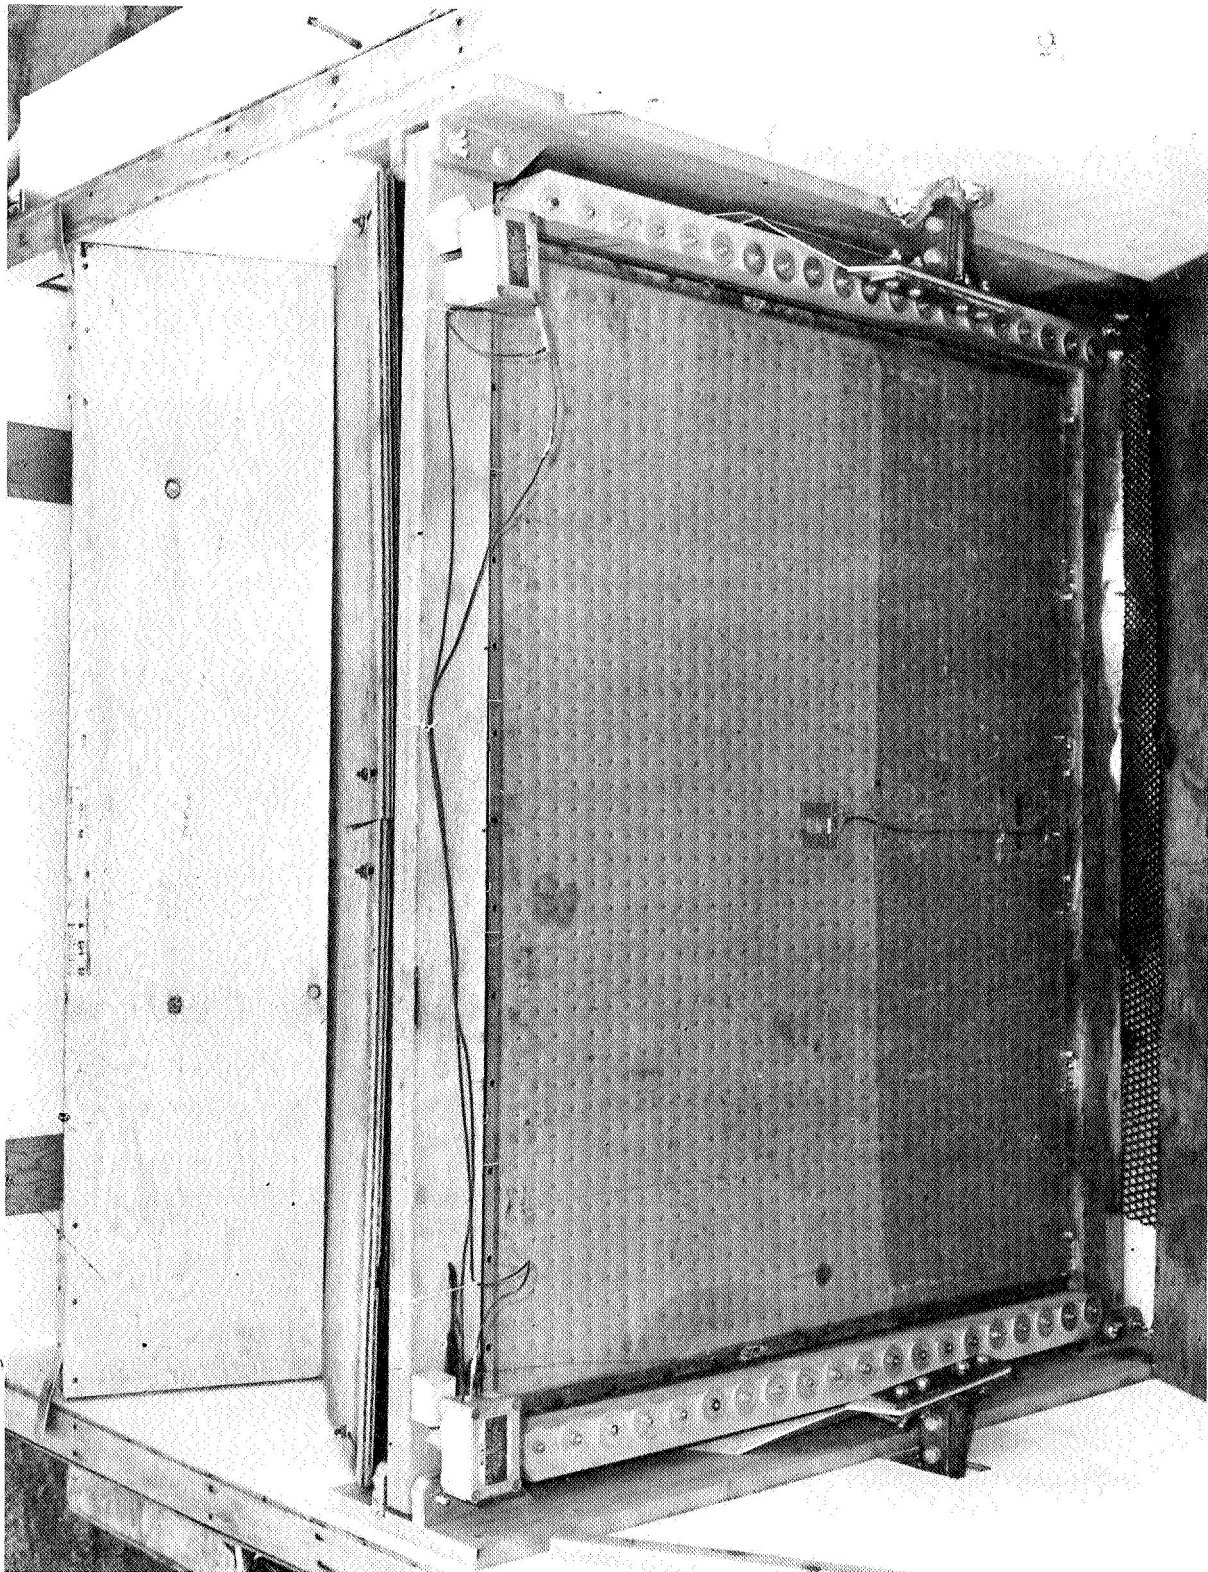
Figure 158.- Typical 40x40-in. Detector Setup

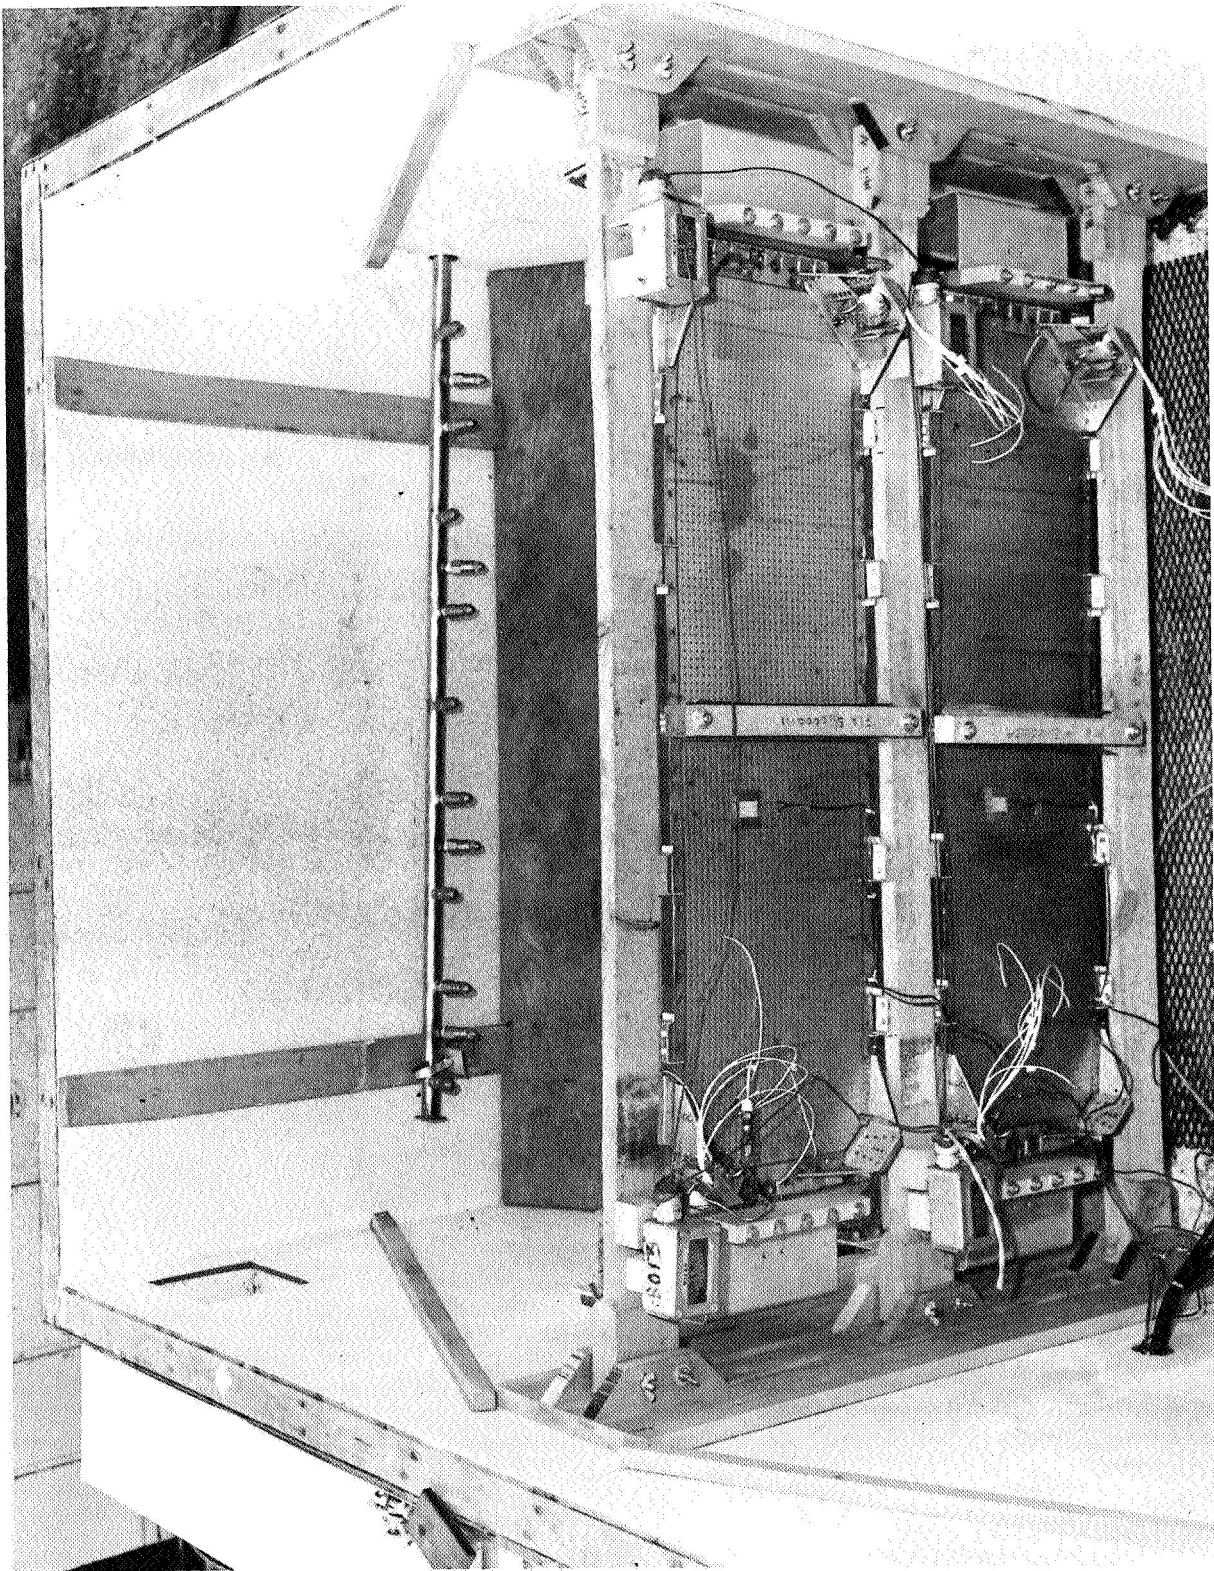
Figure 159.- Typical 12x40-in. Panel Setup

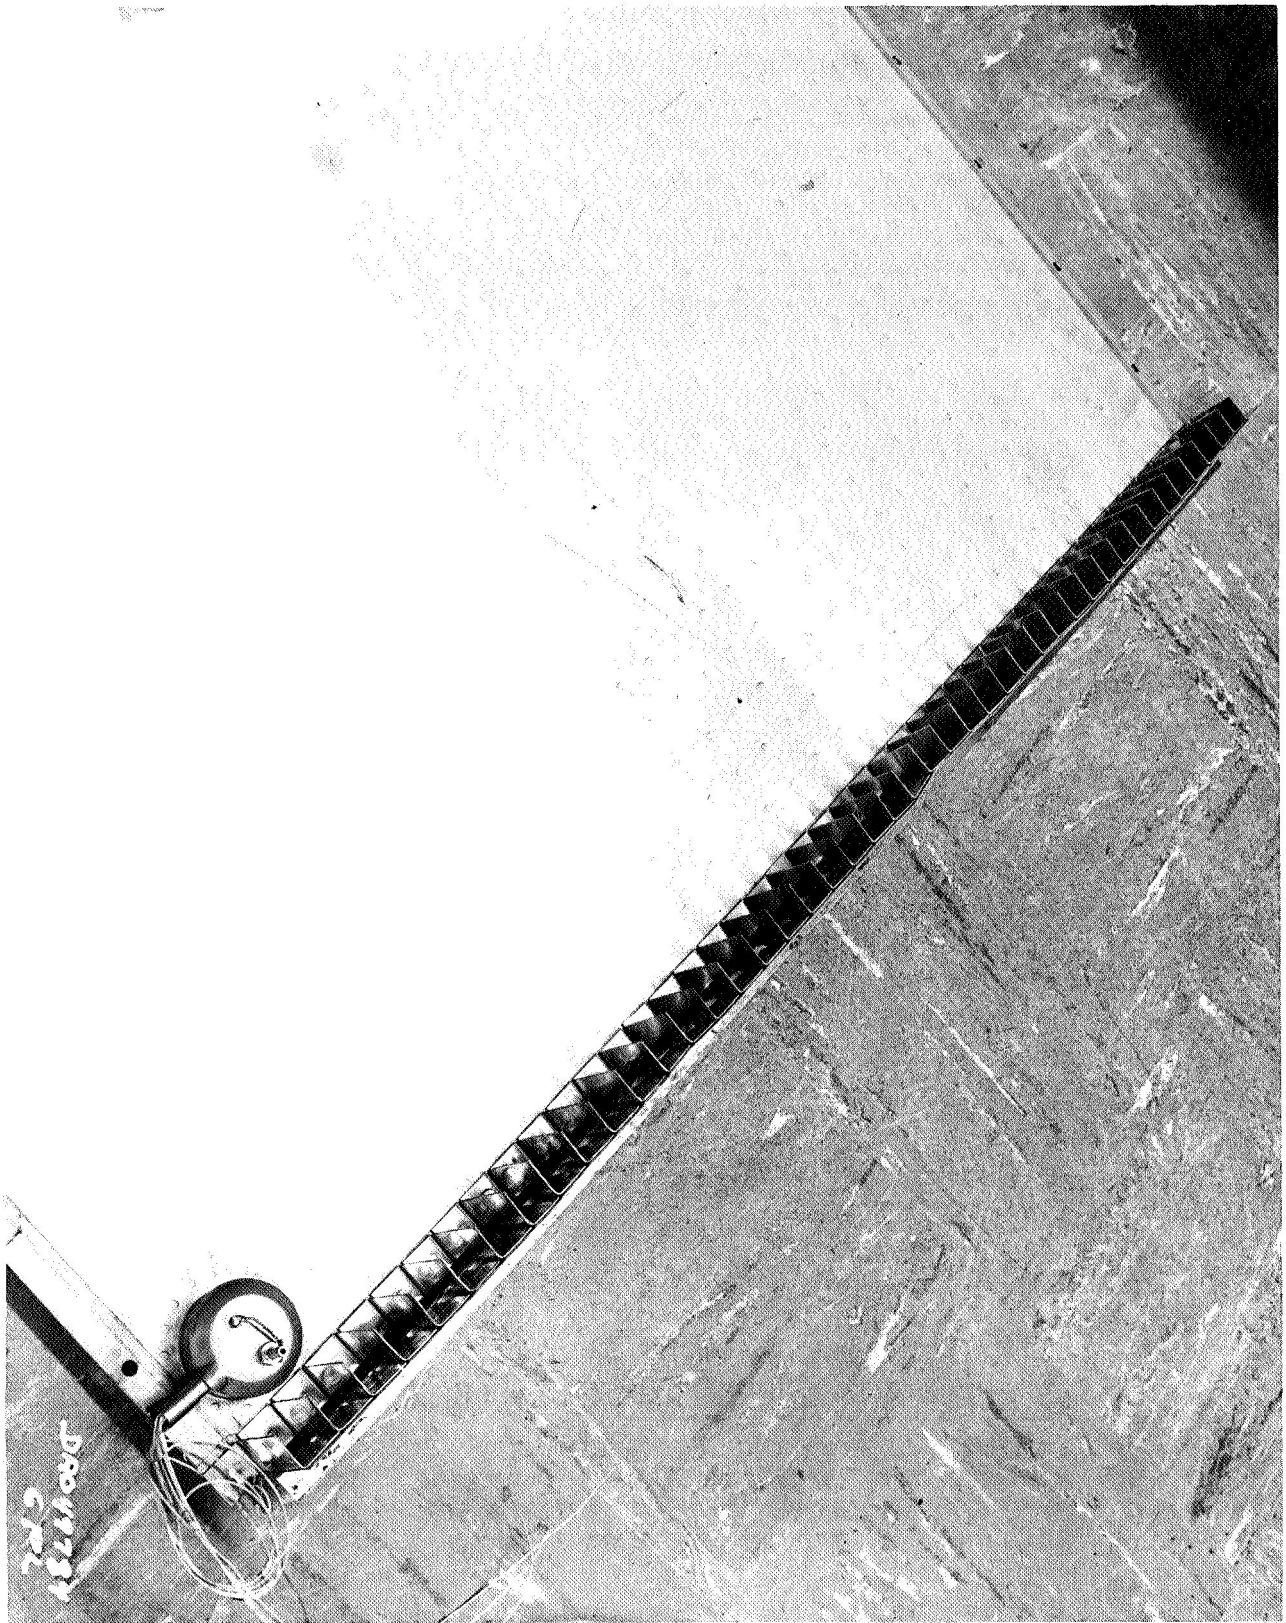
Figure 161.- Typical 40x49-in. Current Conduction Fingers

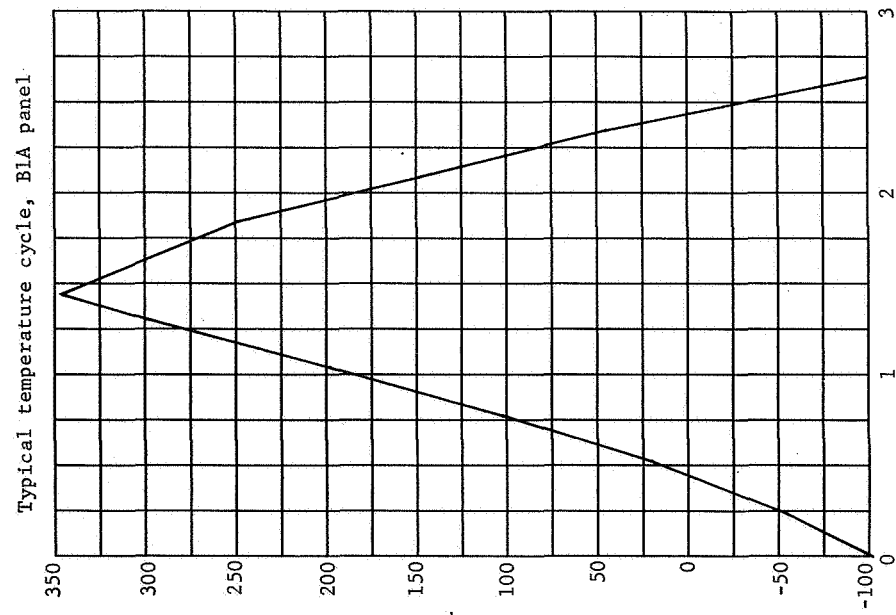
Figure 162.- Typical Temperature Cycle, 325°F, -100°F Requirement

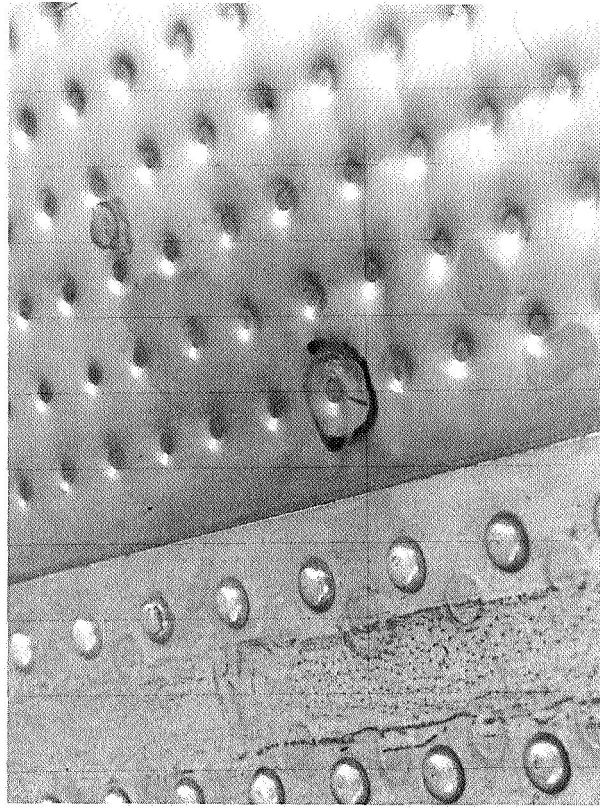
Figure 165.- Leak and Stress Area, F1A, S/N 0000103A

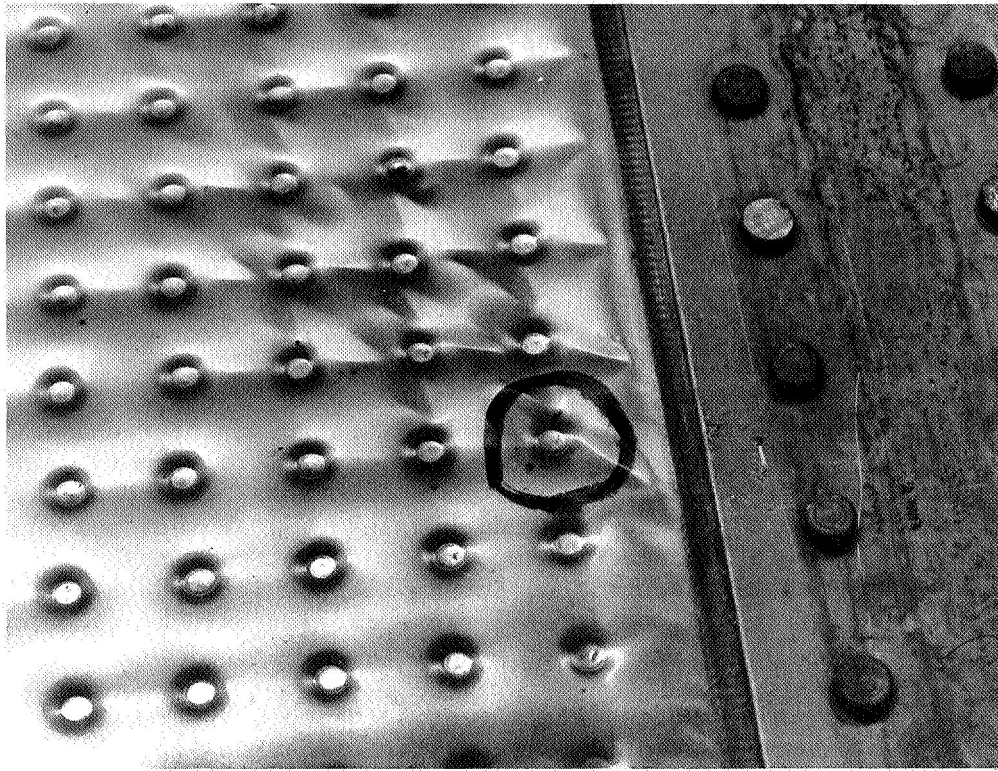
Figure 166.- Leak and Stress Area, F1A, S/N 0000111

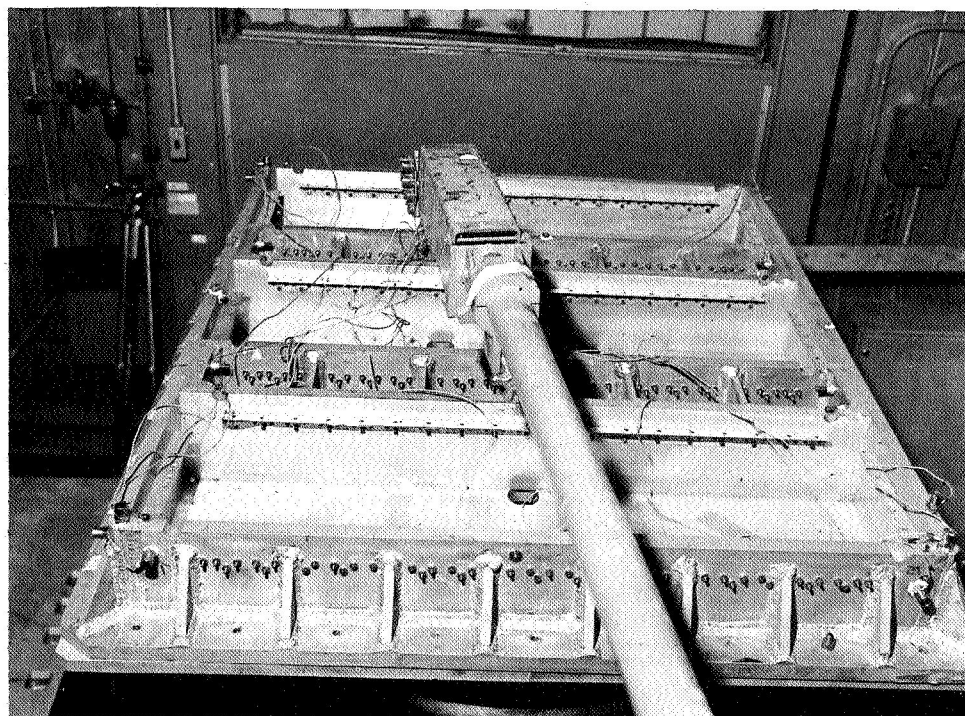
Figure 171.- 12x40-in. Configuration, Out-of-Plane Axis

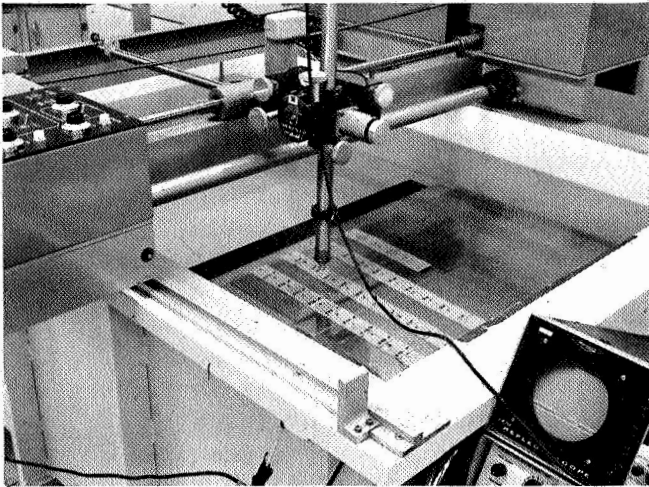
Figure 174.- Ultrasonic Inspection of .016-in. Welding Samples
